2.0 Edgemont

Edgemont Site Long-Term Custody Compliance Requirements

Edgemont Site Inspection Results

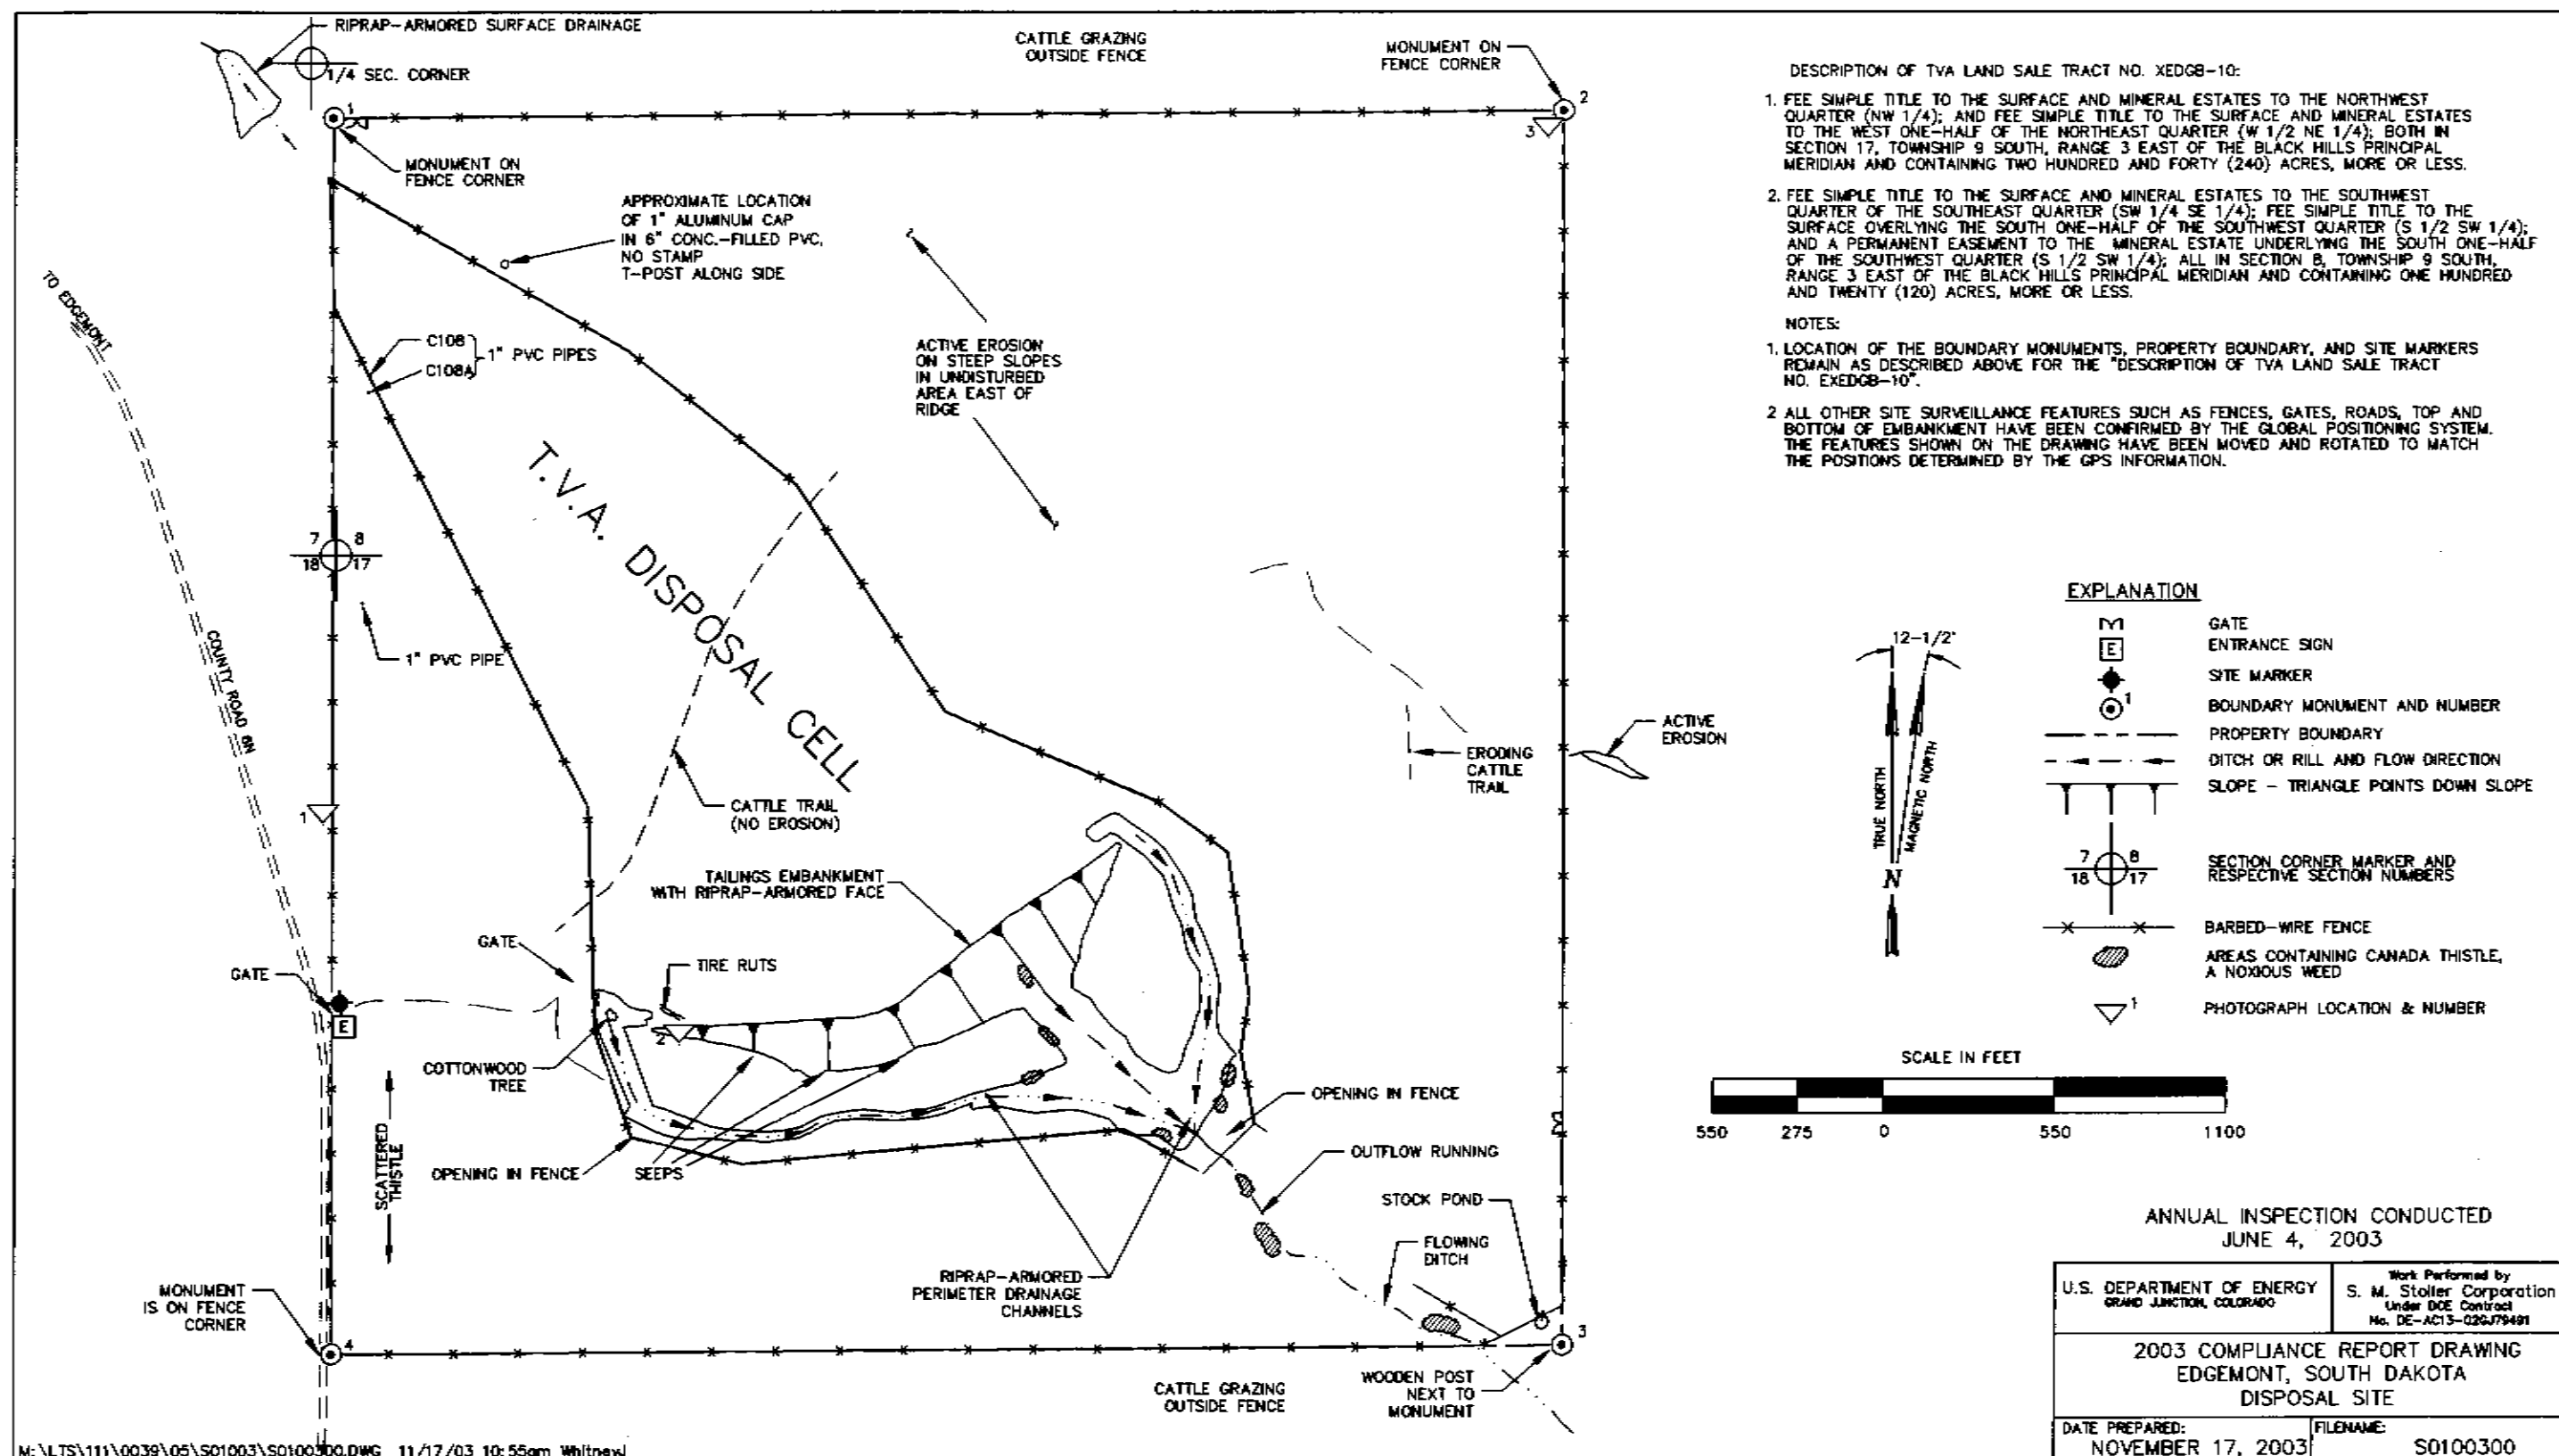
Figure 2-1. Edgemont, South Dakota, 2003

A four-strand barbed-wire fence was installed in spring 1999 along the site boundary to demarcate DOE property and to control grazing on the property. The entire fence line was walked to inspect the fence and the boundary monuments. Minor fence repairs, including tightening two strands of wire on the west boundary and reattaching wire to the t-posts, were conducted during the inspection. Based on the condition of the range inside the fence on site property versus outside the fence, the fence is adequately preventing unauthorized grazing. The fence is in excellent condition (PL-1).

The tailings dam face, the steepest slope on site, is covered with riprap. The slope is stable and the riprap shows no signs of degradation. Scattered plants, mostly grass, grow in the riprap (PL-2). These plants do not pose an immediate threat to stability or function of this structure. The plant density has not increased over the last few years. Plant density in the riprap dam face will continue to be evaluated during future inspections.
